Status of electro polishing

At DESY

A.Matheisen

Part 2 Status at DESY

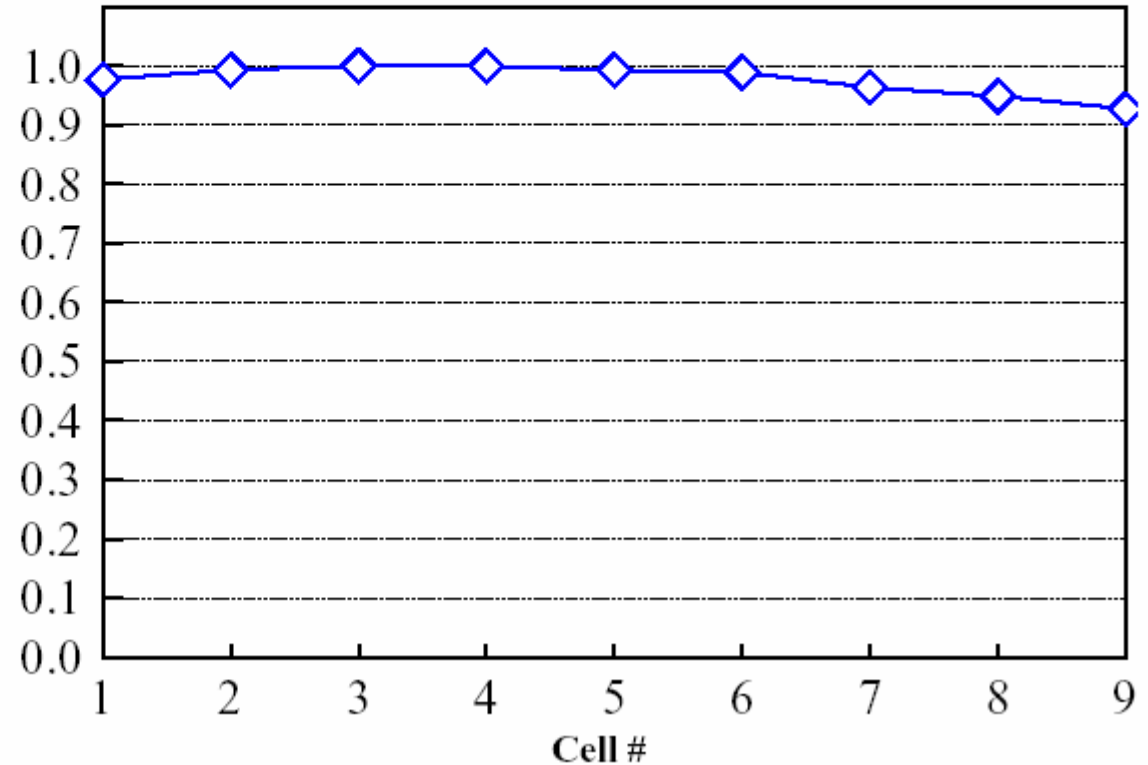
MODE SPECTRUM MEASURED ON TUNING MACHINE

Cavity AC80

Measured on 18-Nov-2003 12:08

Field Flatness [%]: 93

Cell #	Amplitude	Norm. Amplitude
1	128.8546	.98
2	-130.9845	-.99
3	131.9219	1
4	-131.8478	-1
5	130.9782	.99
6	-130.4558	-.99
7	127.0833	.96
8	-125.1464	-.95
9	122.2745	.93

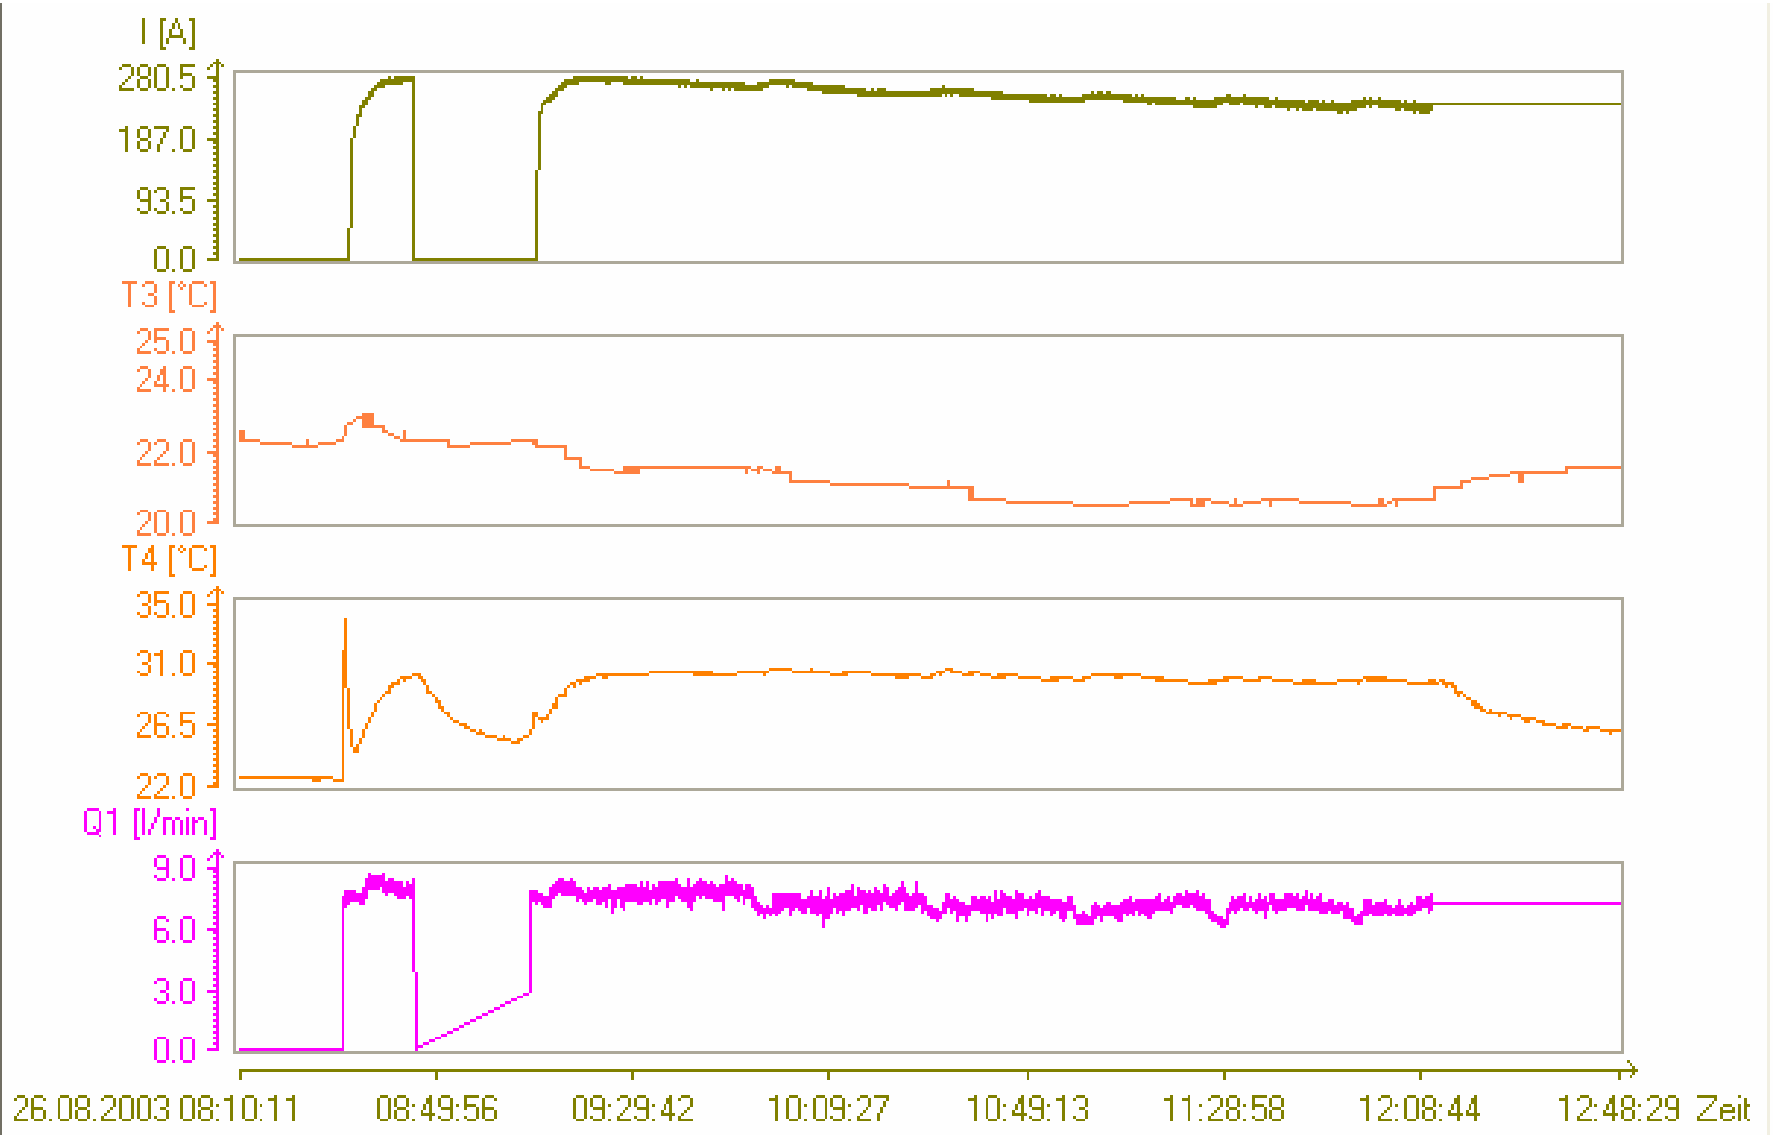
EP data of cavity P-1 26.8.03

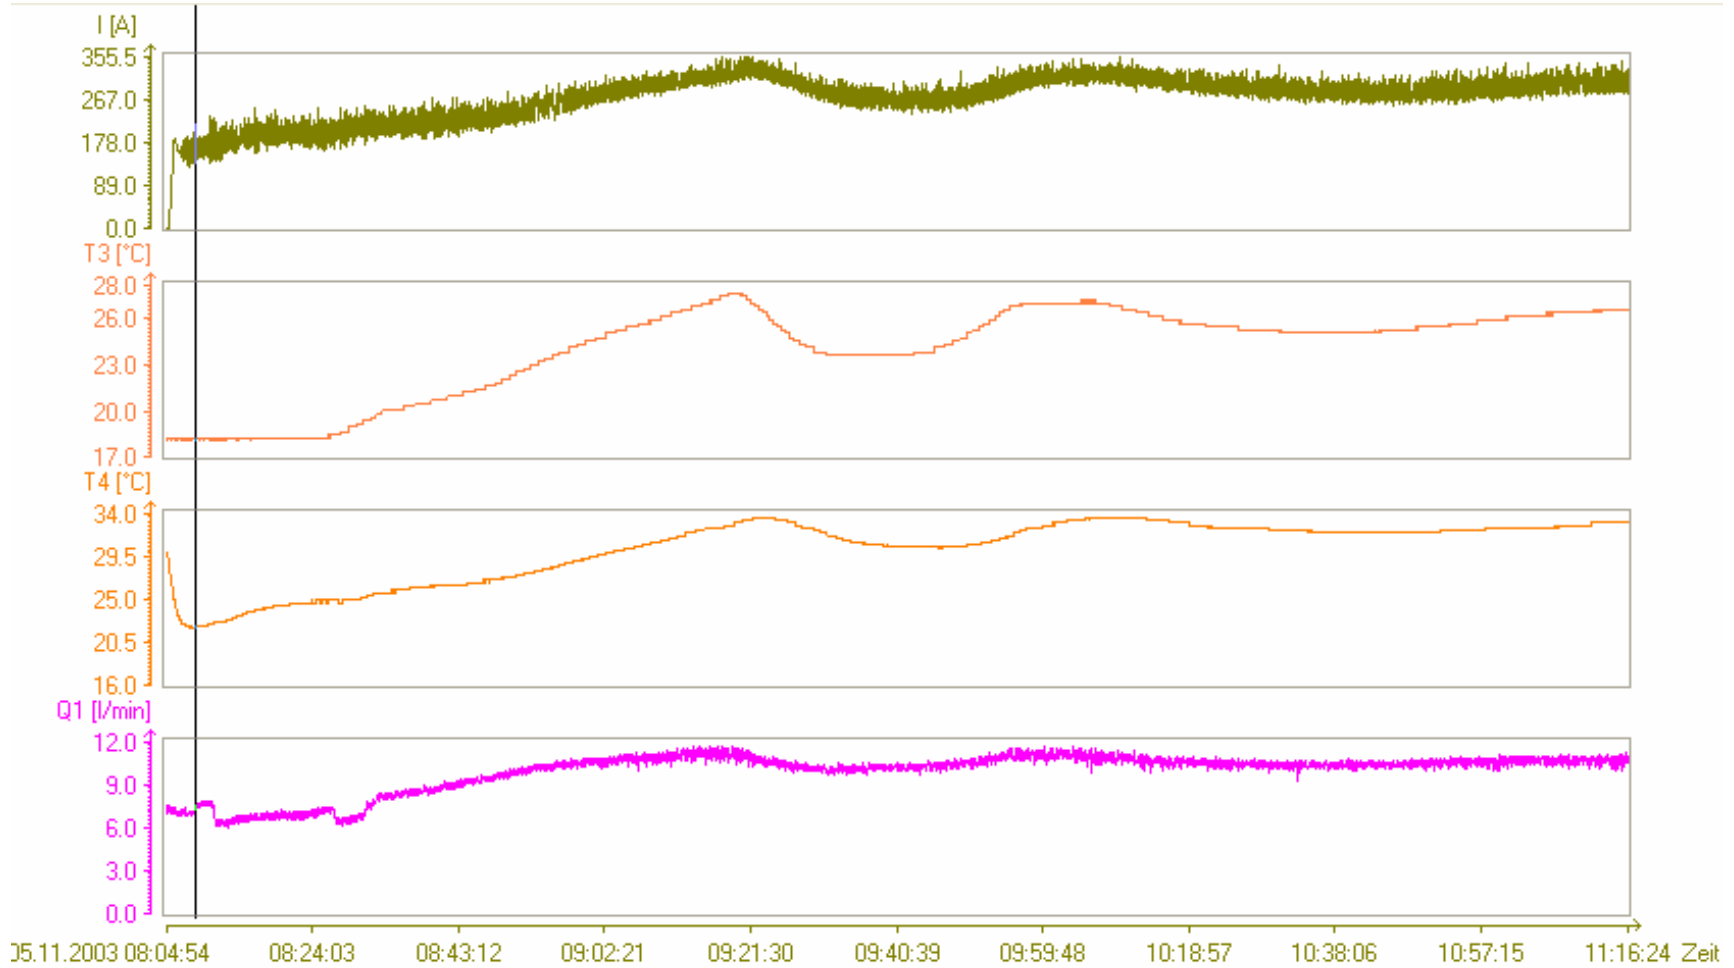
EP data of cavity

AC 80 5.11.03

Prozesswerte			
Kurve	Variablenanbindung	Wert	Datum/Zeit
Strom	Netzteilwerte\Strom	216.58	05.11.2003 08:08:38.870
T3: WT 1 Ablauf	Temperatur\T3_Waermetauscher1_Ablauf	18.3	05.11.2003 08:08:38.870
T4: WT 2 Zulauf	Temperatur\T4_Waermetauscher2_Zulauf	22.1	05.11.2003 08:08:38.870
Q1: Säuredurchfluss	Durchfluss\Q1_Saeuredurchfluss	7.35	05.11.2003 08:08:38.870

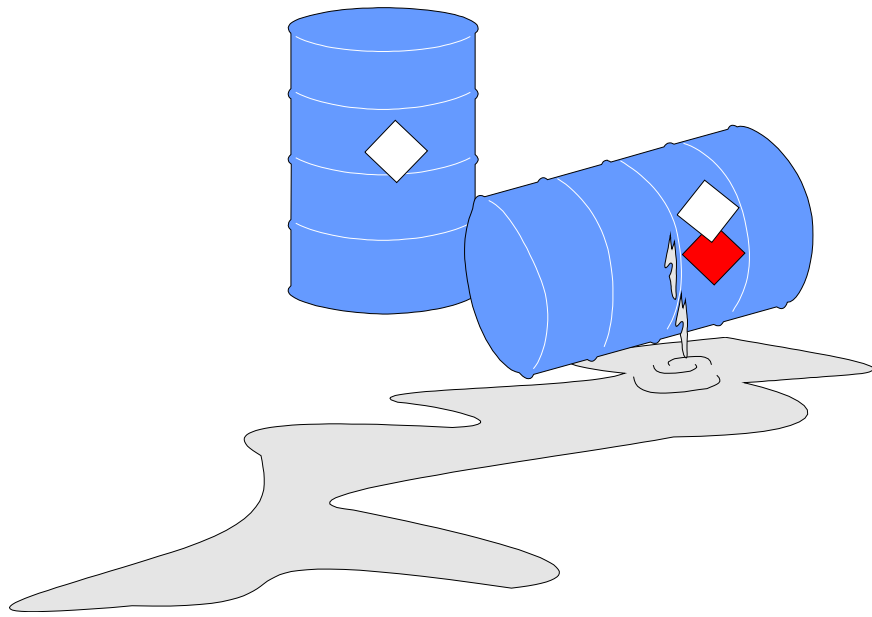
We had a problem with one of the ep acid vessels
